Manhole Inspection Summary

Manhole # S71E1_017MH

Insp Date: **2/14/08 10:28 AM**

Location Address: **6520 Saint Helena Ave.**

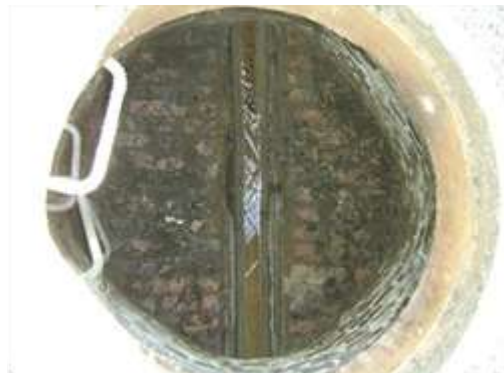
Top View

Condition: ☐ Sound ☐ Cracked ☐ Root Intrusion ☒ **Loose Brick** ☐ Deteriorated

Infiltration: ☐ None ☐ Joint ☐ Cracks ☒ **Mortar** ☐ Roots ☐ Wall

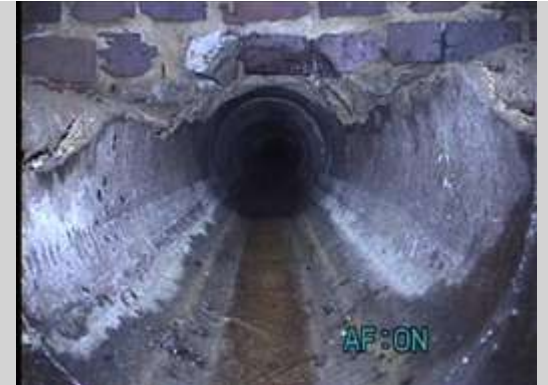
12 O'Clock Outflow

8 in. Circular Gravity Sewer
Pipe Out @ 12 O'Clock

Pipe Height: **8.4** (in.) Rod and Bar (Angled)
Pipe Material: **Clay** ☐ Pipe Lined
Invert Depth: **6.21** (ft.) Flow Characteristics: **Slow**
Deposits: ☒ None ☐ Mud ☐ Sludge ☐ Debris ☐ Grease
Silt Depth: (in.) Deposits Extent:
Infiltration: **None** Pipe Seal Cond: **Sound**

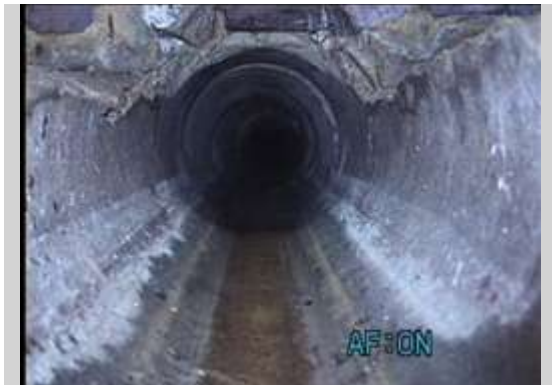
6 O'Clock Inflow

8 in. Circular Gravity Sewer
Pipe In @ 6 O'Clock

Pipe Height: **8.4** (in.) Rod and Bar (Angled)
Pipe Material: **Clay** ☐ Pipe Lined
Invert Depth: **6.17** (ft.) Flow Characteristics: **Slow**
Deposits: ☒ None ☐ Mud ☐ Sludge ☐ Debris ☐ Grease
Silt Depth: (in.) Deposits Extent:
Infiltration: **None** Pipe Seal Cond: **Sound**
